Physical Environment MRI Safety

2022 Dubai Advanced MRI Safety Seminar

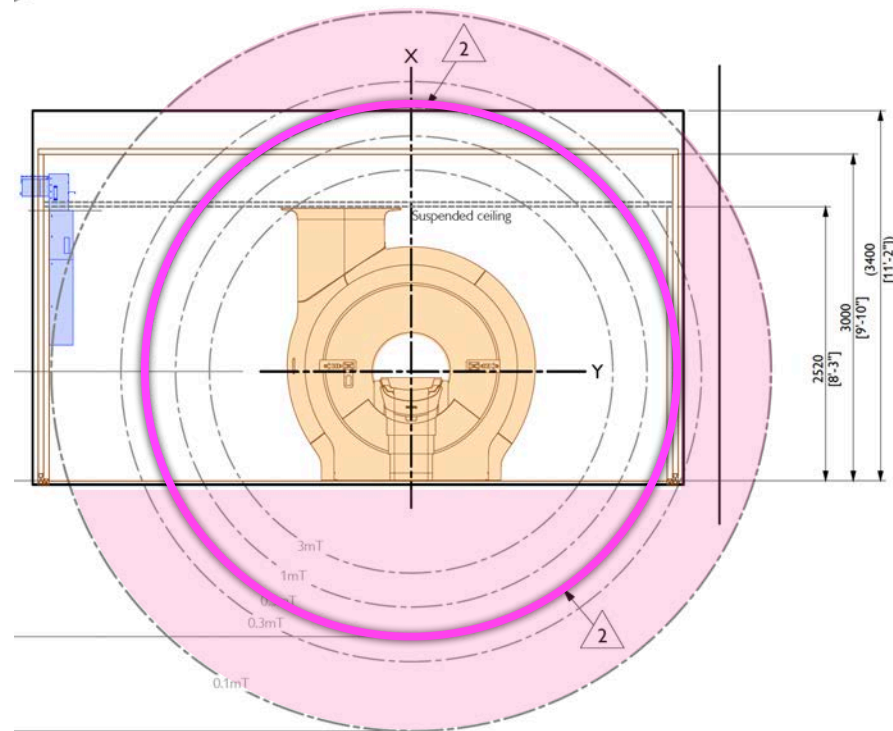
9 Gauss (0.9 mT) is the new 5 Gauss (0.5 mT)

- Last month the IEC changed the standard for static field safety for unscreened persons from 5 Gauss (0.5 mT) to 9 Gauss (0.9 mT)
- IEC governs *manufacture* of MRI equipment, but this change has obvious implications for all existing MRIs
- US FDA does not have independent safety standard... they reference IEC
- I understand EU regulation references ICNIRP, so perhaps more steps

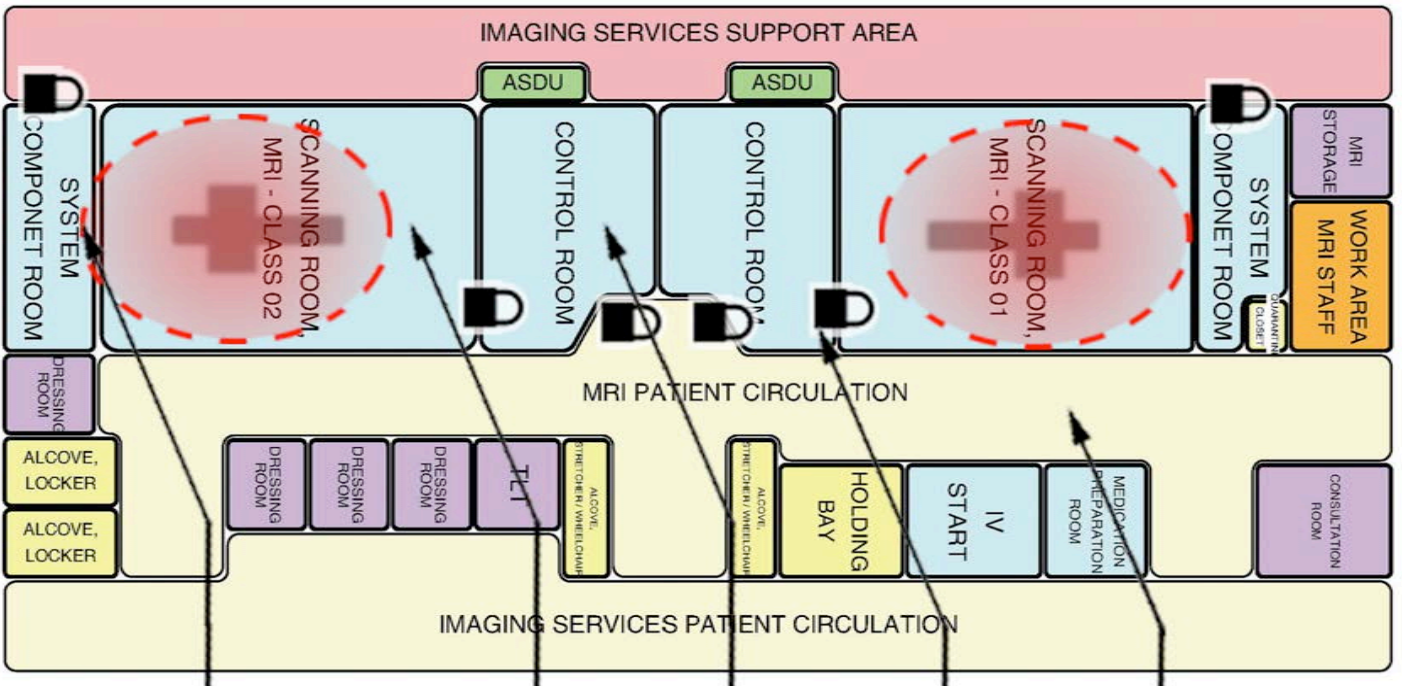
Zone 2:
Unsecured area for patient screening and preparation.

Padlock indicates locked / lockable point of access throughout.

Zone 3:
Direct access to Zone 4 (MRI Scanner Room).

Zone 4:
MRI Scanner Room.

Zone 3:
Potentially dangerous magnetic fields may extend into adjacent rooms on same floor, and vertically into rooms above and below.

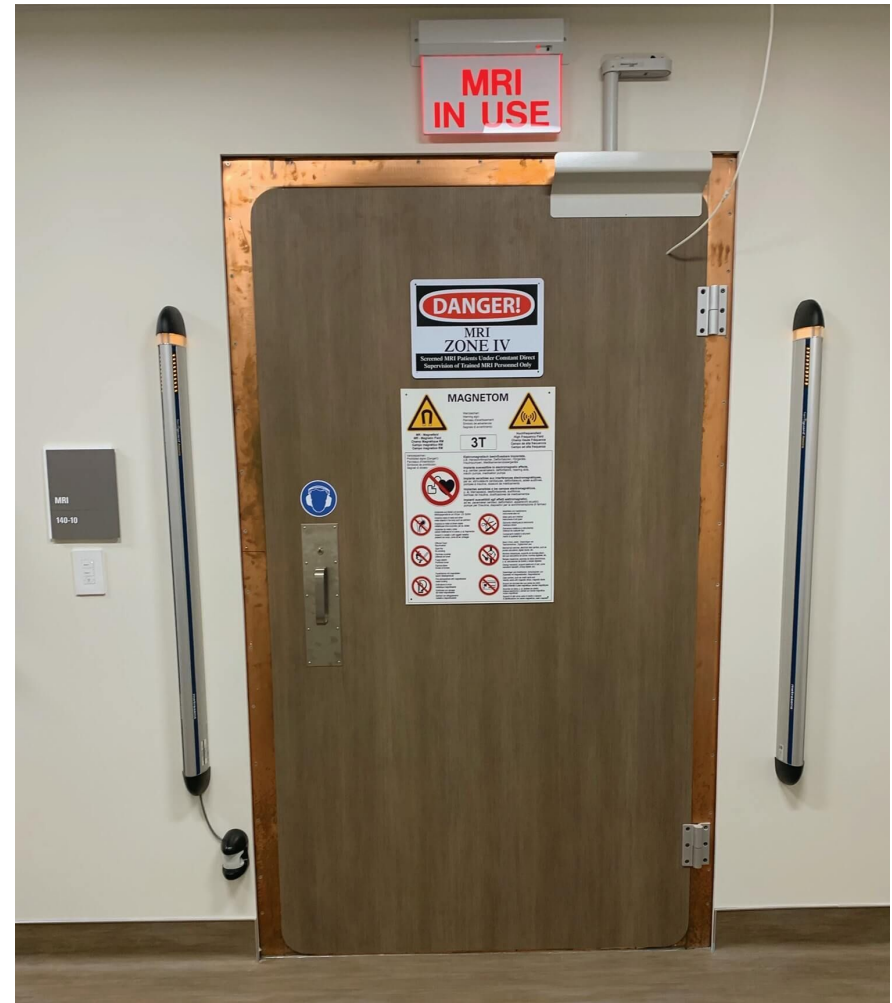
- Door to Zone 4 is the *absolute last chance* to catch hazard items

**MRI
IN USE**

DANGER!
**MRI
ZONE IV**
Screened MRI Patients Under Constant Direct
Supervision of Trained MRI Personnel Only

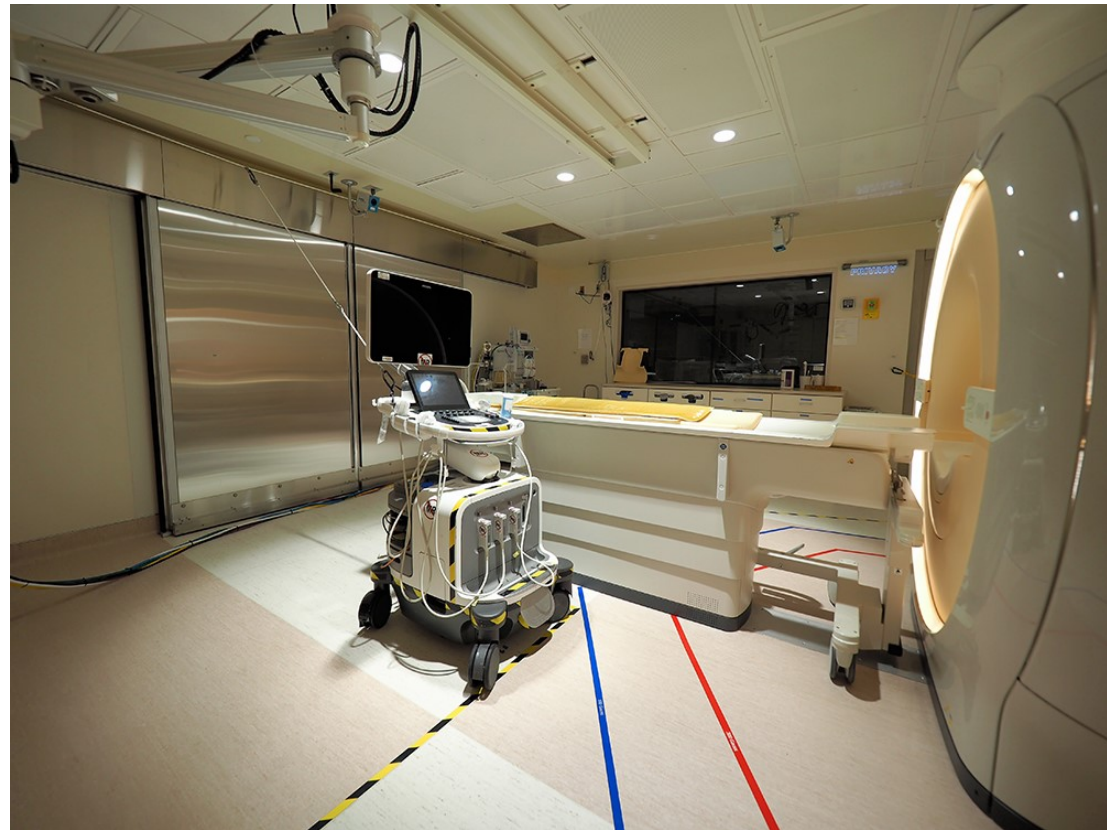
When supporting the use of non-MR Conditional portable equipment outside the MRI Scanner Room (Zone 4), such as horizontal patient transfer devices, infusion pumps, or patient monitors, planners shall provide anchoring tether-points to allow each individual portable piece of non-MR Conditional equipment to be tethered to prevent its inadvertent introduction into the MRI Scanner Room.
